Riparian Prescriptions for the Lower Cluxewe River Watershed Summary Report

November 2007

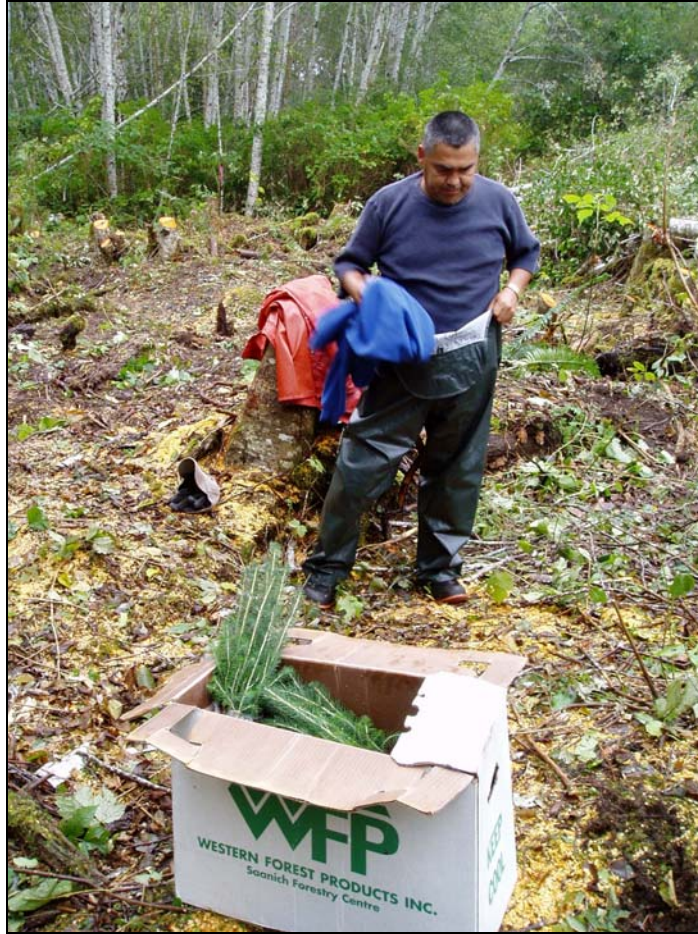
Photo 1. Thomas Wilson preparing to plant in treatment zone 7-2.

The cleared area of treatment zone 7-2 was 474.2m² and contained five microsite planting areas. Microsites within treatment zone 7-2 were consistent in size with those in treatment zone 7-1. Seventy trees were planted within the microsite areas (Photo 1).

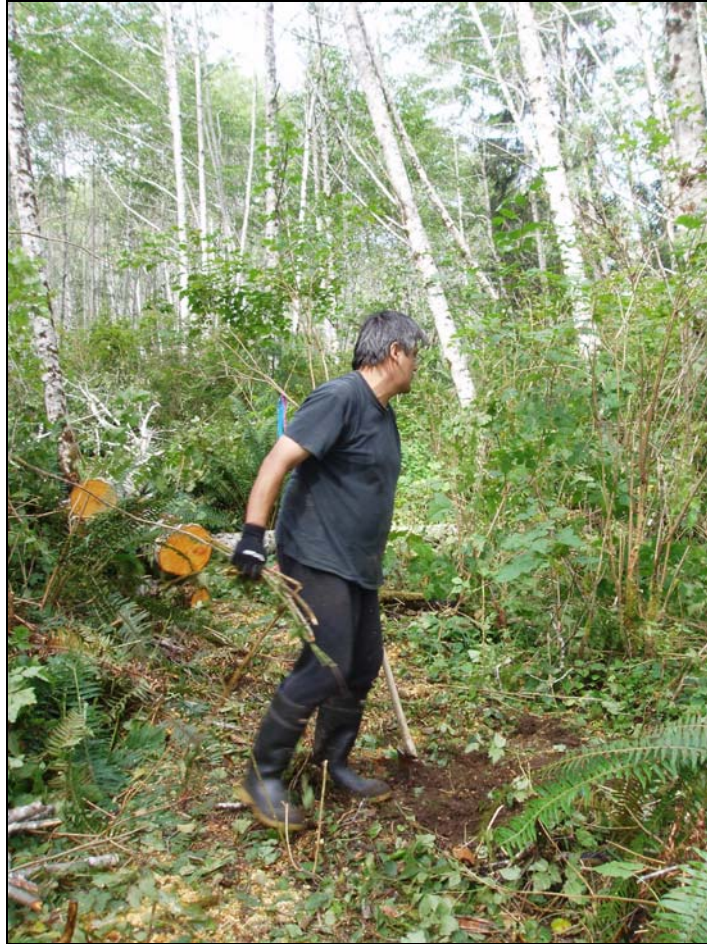
Photo 2. Alfie Scow grubbing in treatment zone 7-3.

Treatment zone 7-3 was the smallest of the three treatment zones with a cleared area of 450m². Due to the relatively small area of treatment zone 7-3, it was decided to plant the entire elevated portion of this site (Photo 2). The elevated area of this site was 150m². Sixty trees were planted on the elevated portion of this site.

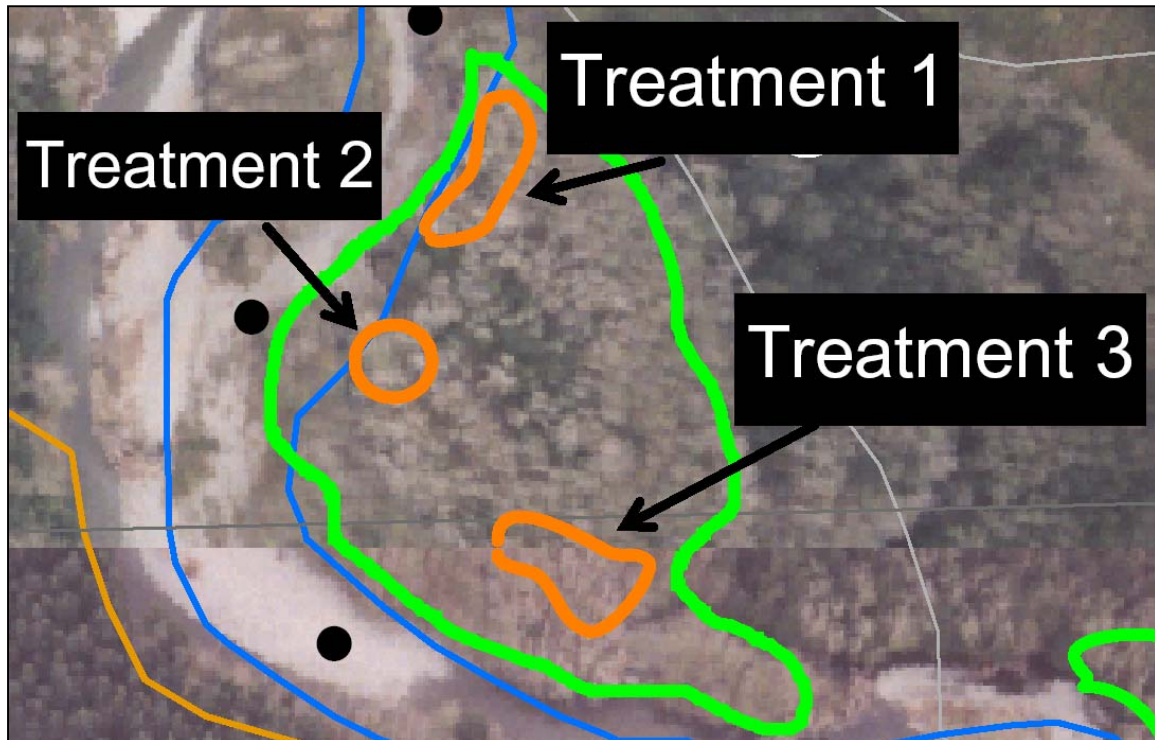
Figure 2: Site 7, treatments zones 1,2,3 (127° 9' 56"W, 50° 36' 10"N).

Site 7 is located approximately 700m upstream from the Highway 19 bridge crossing on the eastern bank (127° 9' 56"W, 50° 36' 10"N). This site was divided into 3 specific treatment zones (7-1, 7-2, and 7-3) (Figure 2).

Treatment zone 7-1 consisted of a cleared area of 804.24m² and five microsite planting areas, 5-8m in diameter. Ninety conifers were planted within the microsities in treatment 7-1.

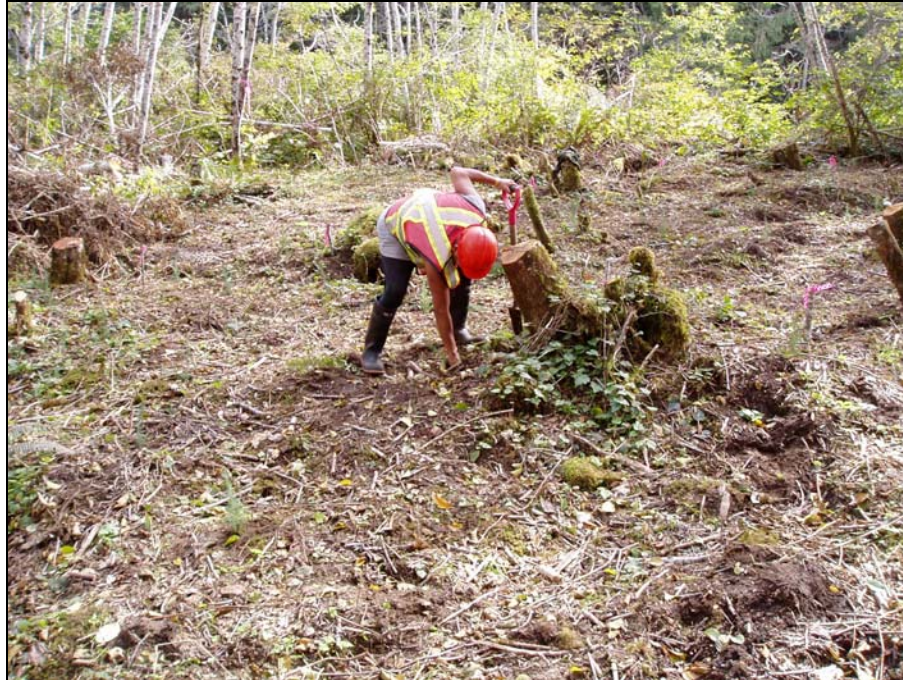
Photo 3. Thomas Wilson planting in treatment zone NS-1.

New Site treatment zone 1 consisted of a cleared area of 480m² and five microsite planting areas, 5-8m in diameter. One hundred conifers were planted within the microsite areas. The close proximity of NS-1 to a pool containing migrating pink salmon (*Oncorhynchus gorbuscha*) warranted extra precautions when falling (Photo 3). Some alder trees in close proximity to this pool were left in place to avoid disruption of the pink salmon.

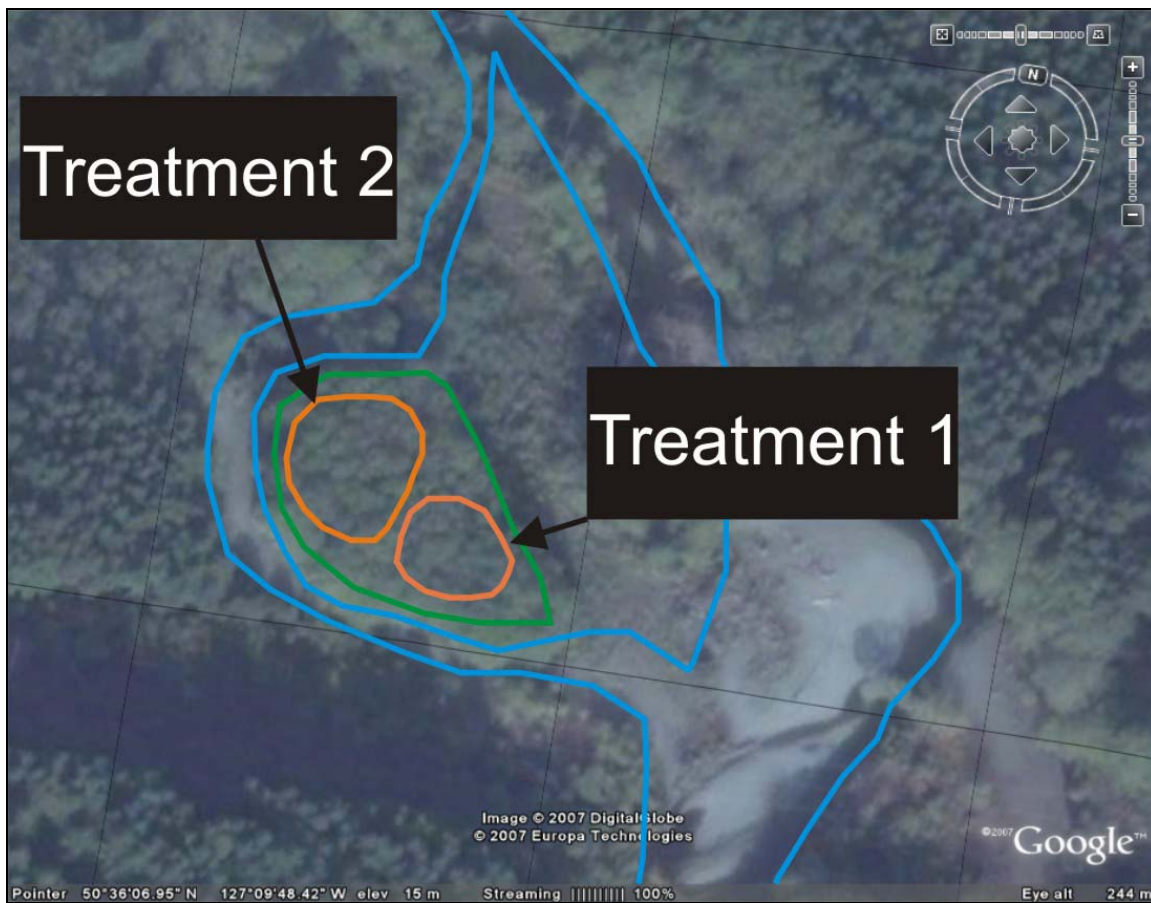
Figure 3: New Site, treatments zones 1,2 (127° 9' 53.1"W, 50° 36' 7.2"N).

The new site is located approximately 1100m upstream from the Highway 19 bridge crossing on the eastern bank (127° 9' 53.1"W, 50° 36' 7.2"N). This site was divided into 2 treatment zones, NS-1 and NS-2 (Figure 3).

NS-2 consisted of a cleared area of 675m² and five microsite planting areas approximately the same size as those contained in NS-1. An additional 100 conifers were planted within the microsite areas.

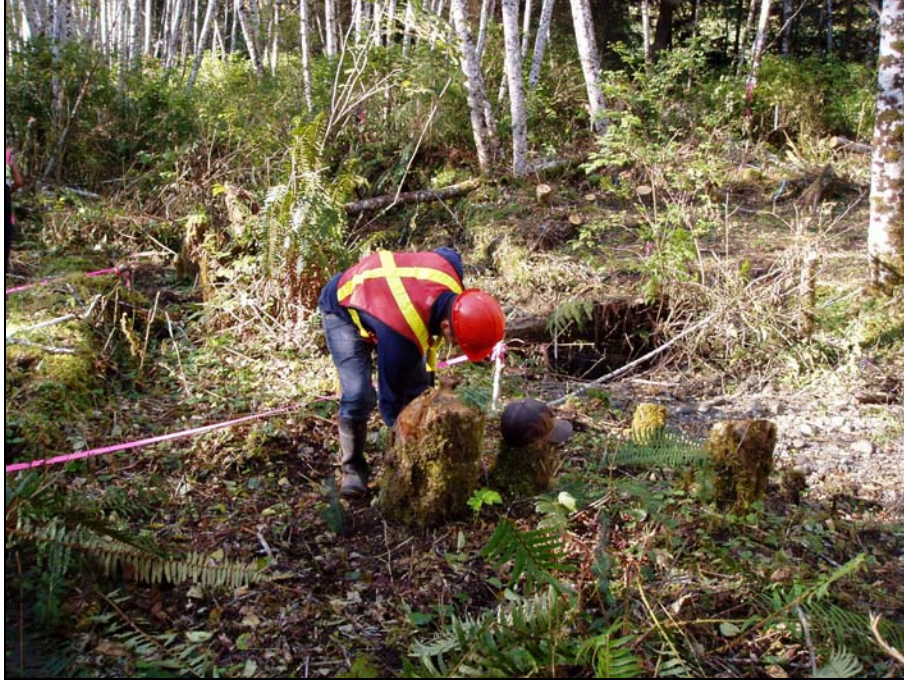
Photo 4. Corey Hunt planting conifers in the 5-8m diameter microsites, treatment zone 12-5.

Treatment zone 12-5 was the largest of the three treatments located within site 12. Treatment 12-5 consisted of a cleared area of 707m². Three microsite planting areas within this treatment zone were cleared. Much of treatment zone 12-5 was highly suitable to conifer planting and contained excellent soil characteristics and suitable elevation. A channel 3m in width bisected treatment zone 12-5 (Photo 4). The entire elevated area located on the western half of 12-5 was prepared for planting and two smaller microsites 5-8m in diameter were also prepared. Within treatment zone 12-5, 210 conifers were planted. The majority were planted on the western half of the site in the largest of the microsites (Photo 5).

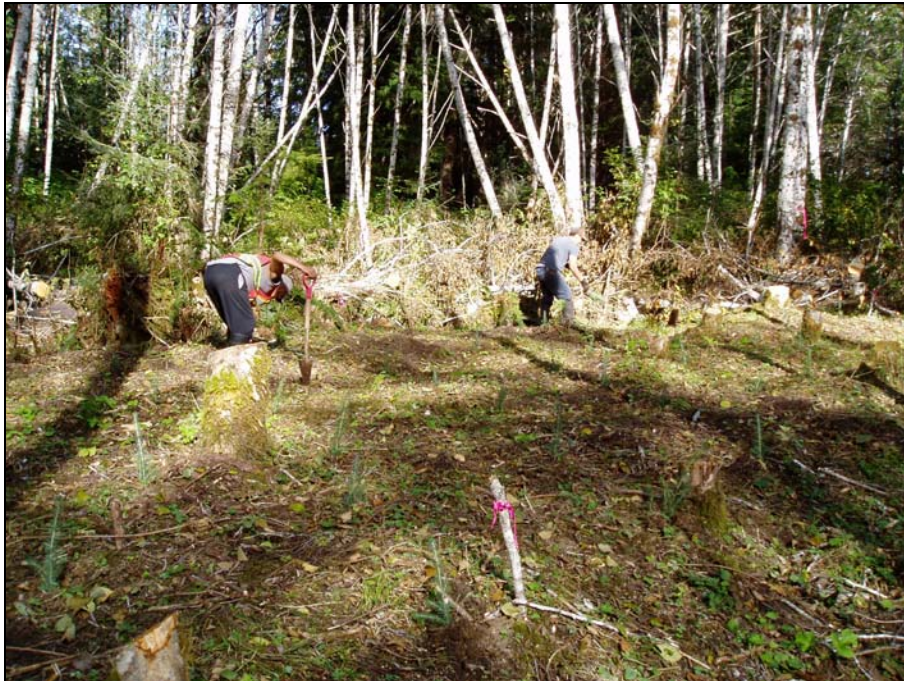
Photo 5. Conifers planted in the western most microsite, treatment zone 12-5.
